## End of life for MMI Display PN: 10059355

# Customer Support Note

GJ-20230424  
(Page 2 / 2)  
ECO-23\_00

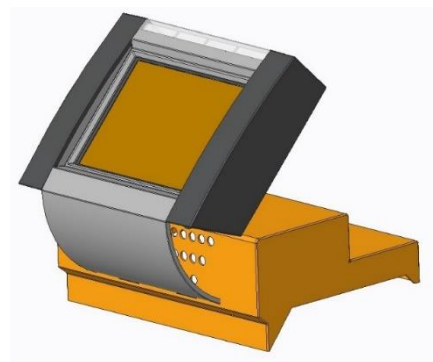
The new solution will provide a better control system and added functionality. It will provide a better and more stable display. Further we can include manuals and offer possibility for installing apps for remote services.

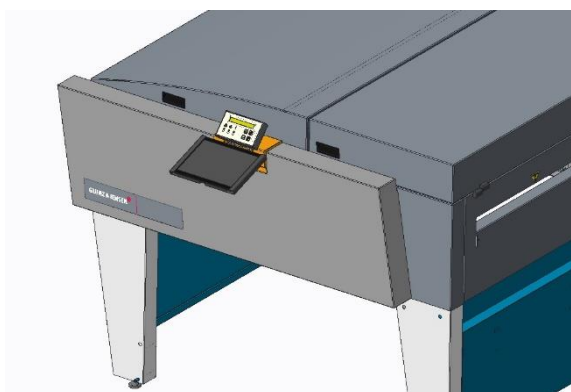
As shown, step 1 is a solution with a simple control panel combined with a Microsoft Surface Go 3 tablet with G&J windows remote enabling system.

The daily usage can be done from the simple control panel. Here you can eject the plate, change program, speed, and temperature. For more advance setup and changes of settings the tablet will be needed.

**Step 1** will be released at the end of May, the old MMI Display will be phased out.

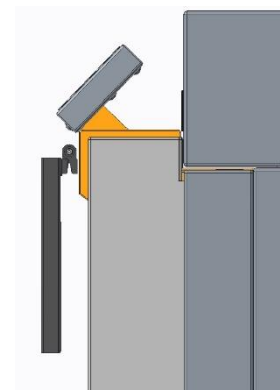
**Step 2** final release will be at the end of October.

As shown, step 2 is a solution with an App for an Android tablet. The App will be very similar to the current interface on the old MMI display.

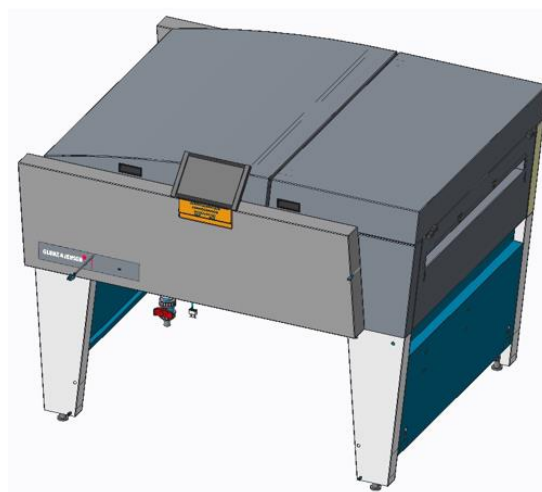
The App will contain all the functionality as is presented today on our current MMI display. The simple control panel will be removed again, and the unit can only be controlled through the App and tablet supplied with our units.
